PROJECT

Benjamin-Powell Smokehouse Colonial Williamsburg, Virginia

CLIENT

Colonial Williamsburg Foundation Williamsburg, Virginia

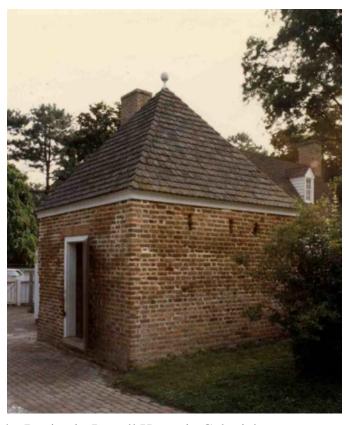
Right: The Benjamin-Powell Smokehouse.

The brick masonry smokehouse adjacent to the Benjamin-Powell House in Colonial Williamsburg, Virginia had suffered severe deterioration of both brick and mortar due, apparently, to crystallization of salts. Mortar deterioration was so severe that repointing of the mortar joints was required almost semi-annually. Due to the irregular patterns and rate of deterioration, architectural conservators were hesitant to implement conservation measures without a clear definition of the extent and source of the damage and the mechanism of deterioration.
