High-Rise Apartment Building  
Denver, Colorado

Cracks, spalls, and related damage were observed throughout the height of this high-rise apartment building. Constructed in the early 1970's, the building has a reinforced concrete frame with exterior brick veneer. Through testing and analysis, the cause of the distress was found to be a buildup of stress in the masonry veneer due to the combined effect of brick expansion and frame shortening. A repair program was implemented to relieve veneer stress and accommodate future veneer expansion. A network of electronic gages was also installed to monitor strains at critical locations during the repair process.

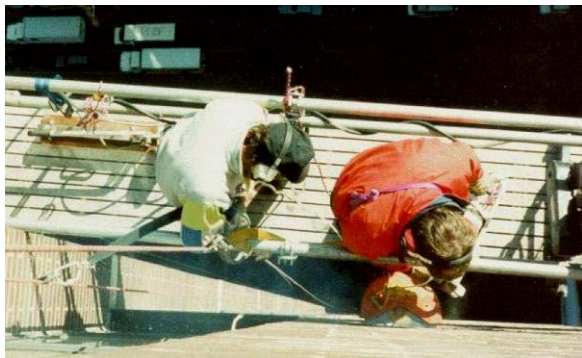
*In situ stress tests, using the flatjack method of ASTM C1196, were used to identify stress buildup over the height of the building. Over 700 psi compression stress was measured in the veneer near the base.*
