Old Senior Hall
Hershey, Pennsylvania

The Ray Group
Lancaster, Pennsylvania

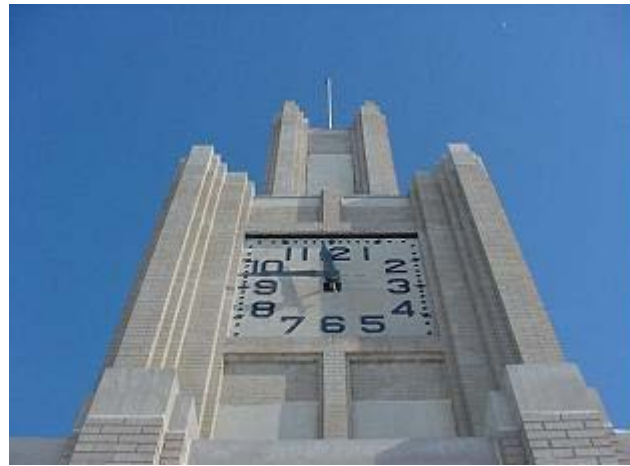
Clock tower at Old Senior Hall

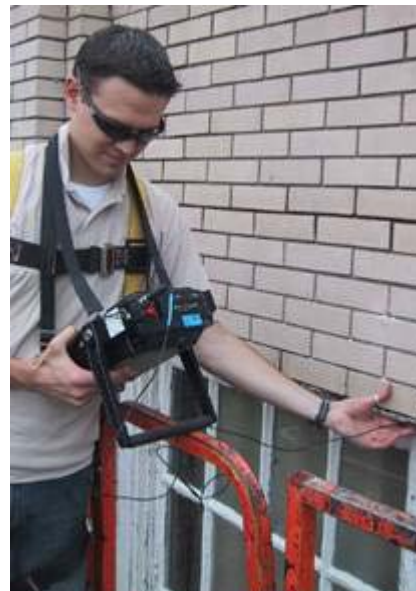
Corrosion of structural steel framing was of major concern. Loss of cross-section due to corrosion was measured at over 550 locations to develop a statistical database for guiding design of a repair methodology.
