181<sup>st</sup> St Station, MTA Line 1  
New York, New York

A partial collapse of the interior wythe of the brick masonry barrel vault at MTA's 181st Station on Line 1 in New York City occurred in 2009. A series of tests were conducted to evaluate the existing masonry construction, provide engineering properties for analysis of the barrel vault, and establish viable repair options.

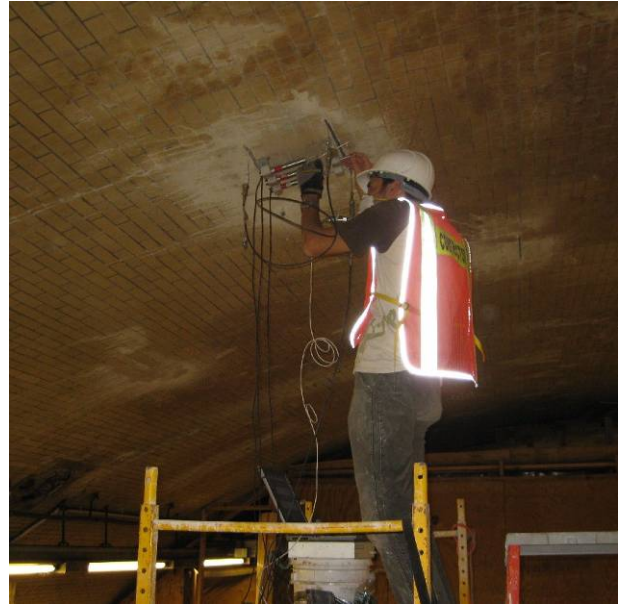
*ANA Engineer conducting flatjack test to determine compressive deformability of the brick masonry vault.*

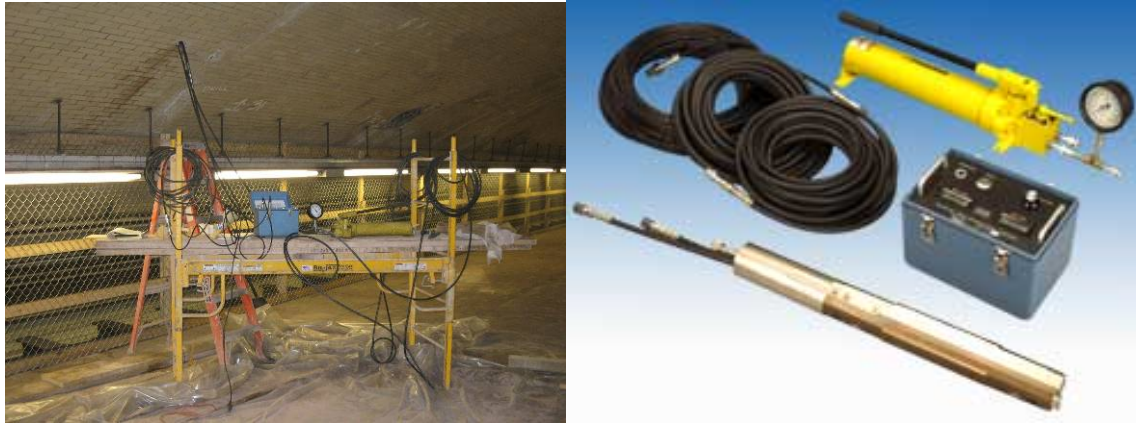
*Goodman jack testing to measure the stiffness of the masonry at various depths within a 4-inch core hole (photograph on right courtesy of Durham Geo Slope Indicator).*

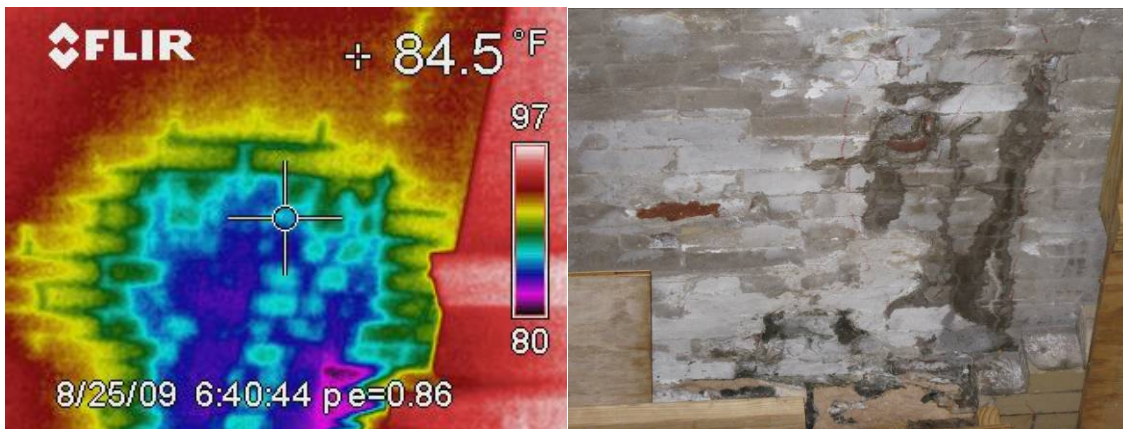
*Thermal image (left) indicates larger moisture extent in masonry than visible light image would suggest (right).*

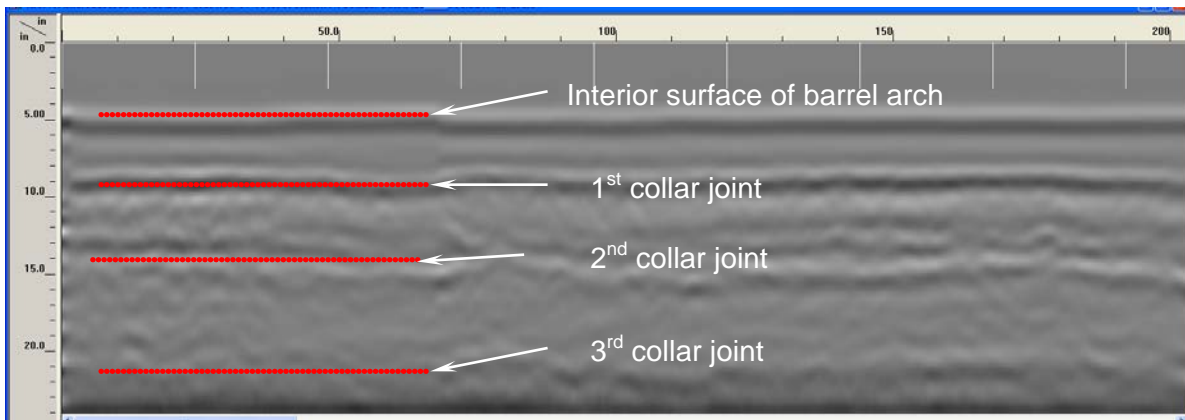
*Impulse radar image from interior of vault indicating generally solid construction.*

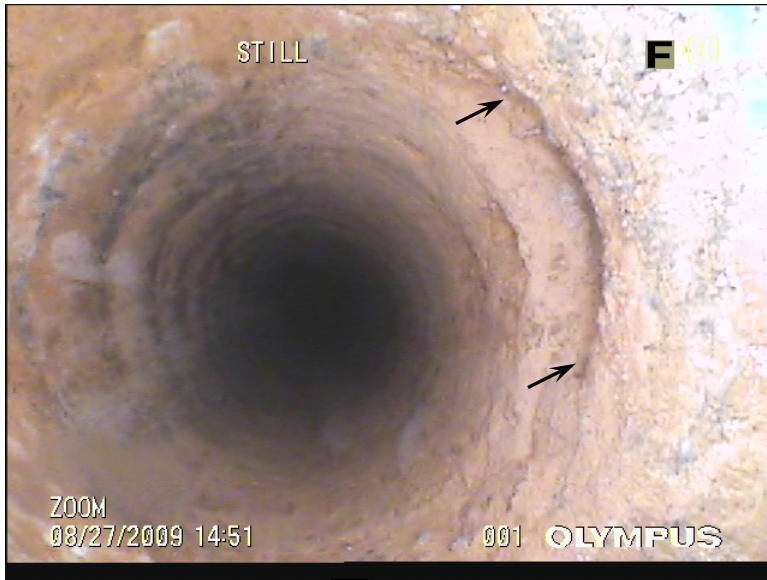
*Minor void detected with microwave radar and investigated using  $3/8$  inch diameter drilled hole and fiber-optic videoscope.*
