PROJECT

Churning of the Sea of Milk Bas Relief
Angkor Wat, Cambodia

PROJECT DESCRIPTION

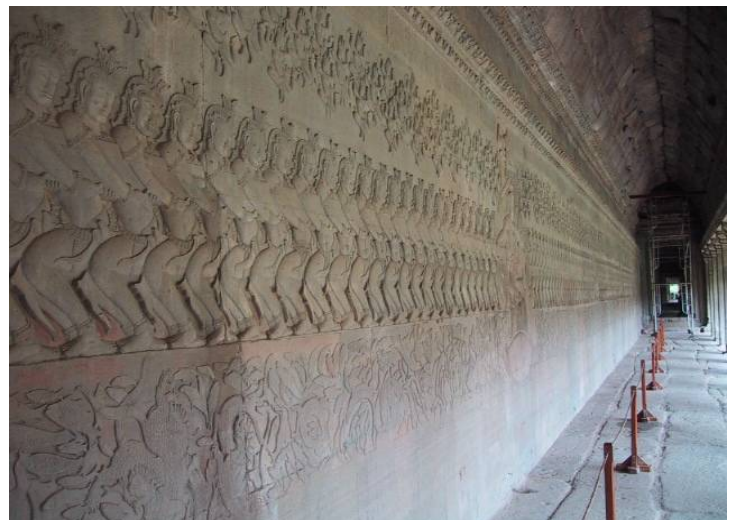
The Churning of the Sea of Milk Gallery

- Microwave radar was used to evaluate the roof section over the gallery to determine stone thickness and to locate and quantify spalls, cracks, and the depth of prior repairs.
- Ultrasonic pulse velocity measurements were used to evaluate the quality of the stone and identify areas of deterioration or discontinuity. Contour maps of through-wall velocity were developed at two locations.
