Benjamin-Powell Smokehouse
Colonial Williamsburg, Virginia

Colonial Williamsburg Foundation
Williamsburg, Virginia

Benjamin-Powell Smokehouse

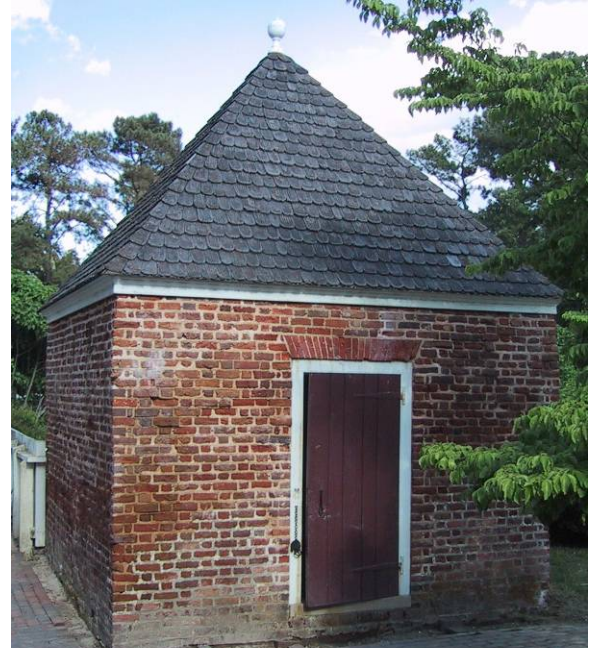
The brick masonry smokehouse adjacent to the Benjamin-Powell House in Colonial Williamsburg, Virginia had suffered severe deterioration of both brick and mortar due, apparently, to crystallization of salts. Mortar deterioration was so severe that repointing of the mortar joints was required almost semi-annually. Due to the irregular patterns and rate of deterioration, architectural conservators were hesitant to implement conservation measures without a clear definition of the extent and source of the damage and the mechanism of deterioration.

Atkinson-Noland worked with Masonry Solutions International to evaluate conditions using nondestructive measures. The team worked with Colonial Williamsburg conservators to develop a scheme to desalinate exterior brick walls. Internal void spaces were first injected with a Compatible Injection Fill (CIF) to provide a monolithic wall section. A de-humidifying system was installed at the interior to draw moisture towards the interior where the salts were collected using a series of poultice treatments. Laboratory testing of each poultice treatment showed that salts were effectively removed after 4 poultice applications.

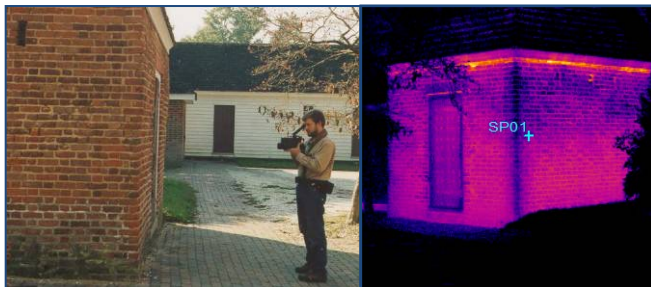
Infrared thermography scanning and image

- Nondestructive evaluation: ultrasonic and mechanical pulse velocity surveys, infrared thermography scans
- Coordination with restoration architects and other structural analysts
- Development of CIF formulation and injection protocols
- Laboratory testing of poultice material to quantify salt content

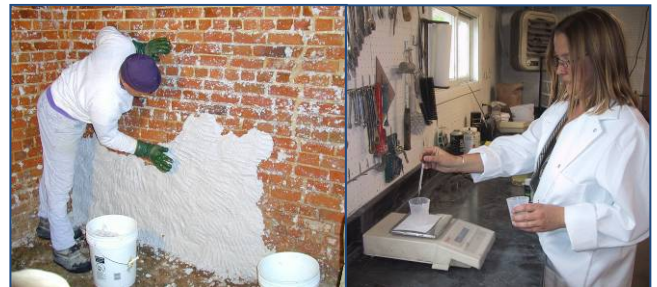
Poultice application and laboratory testing
