Cedar Breaks Overlooks Rehabilitation
Cedar Breaks National Monument, Utah

National Park Service
Intermountain Region
Lakewood, Colorado

The historic overlooks at Cedar Breaks National Monument, built in the 1940's to provide visitors with views of the deep canyons, experienced severe crack formations in the past years that have compromised their structural integrity. Atkinson-Noland & Associates was retained to provide engineering services for site investigations, conceptual repair recommendations, and completion of 100% construction documents for stabilization and rehabilitation of the historic stone walls that comprise North View and Chessman overlooks. Different stabilization solutions were evaluated to protect and preserve the historic nature of the walls. Ultimately, a mechanically stabilized earth wall was chosen as the most appropriate solution for strengthening the existing structures.

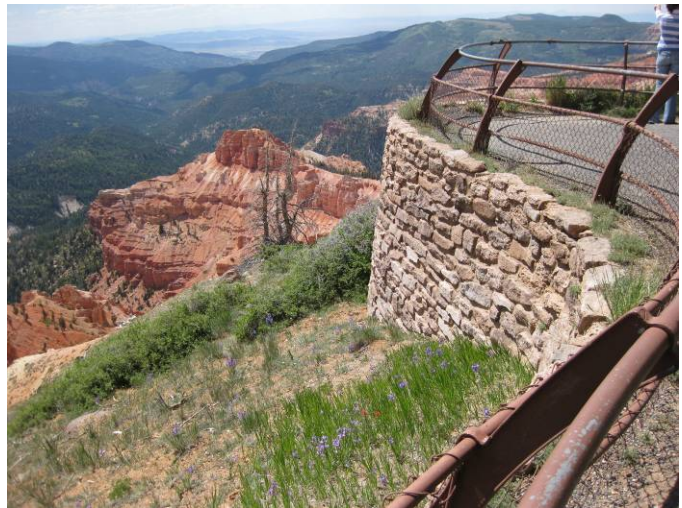
Stone masonry retaining wall at Chessman Overlook, UT

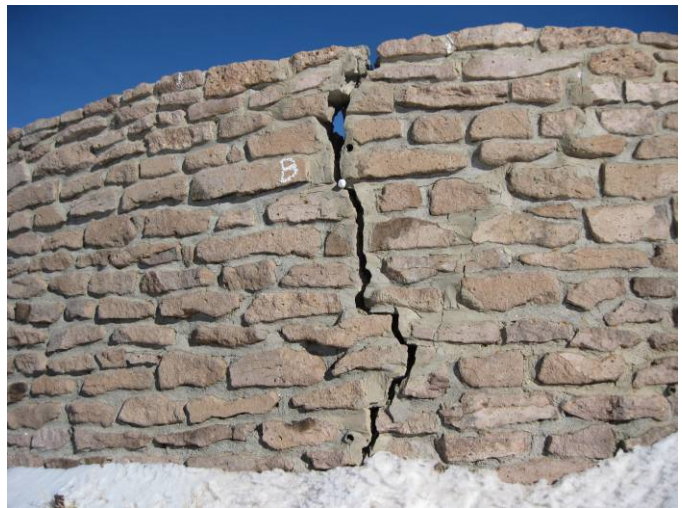
Typical wall crack at the Cedar Breaks Overlooks
