Chamberlin Observatory  
Denver, Colorado

University of Denver  
Denver, Colorado

## PROJECT DESCRIPTION

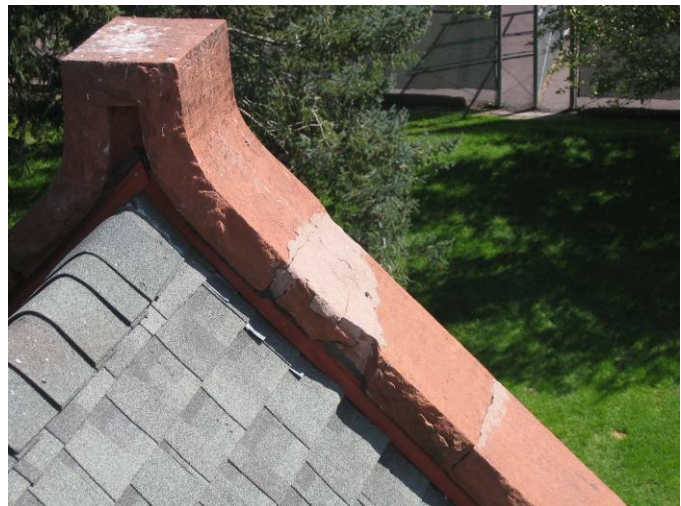
*Stone deterioration at roof*

- Evaluation of the building's stone foundation using borescope investigations
- Identifying voids in the foundation wall and generating a typical wall section
- Mapping mortar hardness throughout using a pendulum hammer on original and repointing mortars
- Laboratory development of materials and protocols for foundation stabilization using Compatible Injection Fill (CIF) injection
- Metal detection for stone anchors
- Identify stone distress and provide repair recommendations
