PROJECT

Grout Injection Feasibility Study
Baltimore, Maryland

PROJECT DESCRIPTION

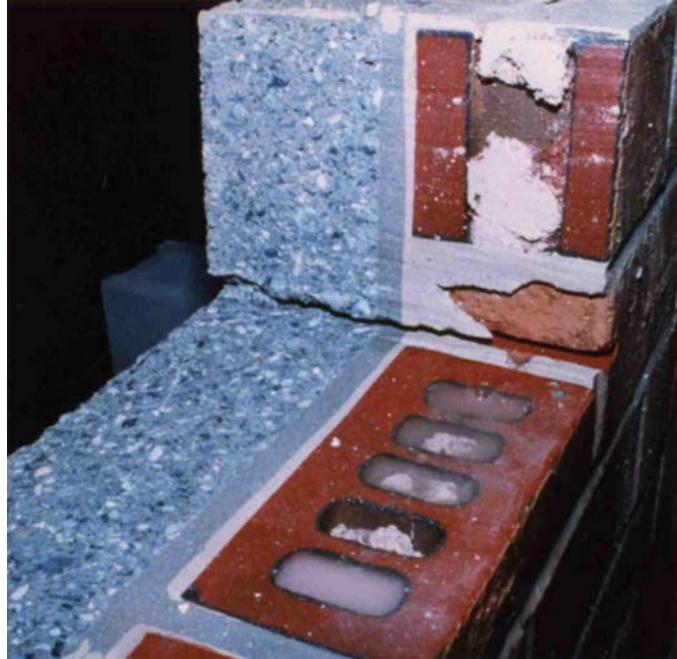
Right: Injected grout (dark colored material) fills empty collar and head joints.

Sample panels were constructed to be representative of in-place construction. An injectable grout with appropriate fluidity and strength was developed and injected into the voids in the sample panels. Following injection, grout penetration was verified by nondestructive tests and visual observation of saw-cut panels. The injected grout showed excellent penetration, completely filling all cavities and unfilled joints.
