Hope Evangelical Church
Westcliffe, Colorado

PROJECT DESCRIPTION

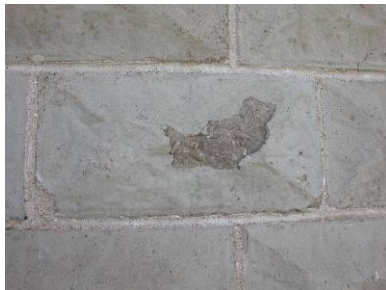
The church was built in 1917 of concrete masonry blocks that were reportedly cast on site by members of the church. The main problem with the church exterior is the delamination of the exterior skin of the concrete block.

Typical delamination in site-cast units

- Evaluation of the site cast masonry units.
- Absorption testing of the face and interior concrete mixes.
- Prepared recommendations for repairs and replacement unit face shells.

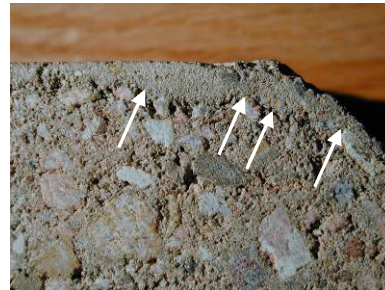
Sawn cross section of unit showing face mix

The face mix is a dense, cement rich mixture containing aggregate no larger than $\frac{1}{8}$ inch. The remainder of the mould was filled with a coarse concrete mixture containing aggregates as large as 1 inch. The concrete materials were hand tamped into the mould.
