Merchant's House Museum  
New York, NY

A new building was planned adjacent to the Merchant's House Museum. Foundations for the new building were planned in close proximity to existing Merchant's House Museum foundations. There was a concern that the anticipated foundation settlement in the new building could result in damage to the 1832 landmarked historic plaster covering the interior surfaces of the House.

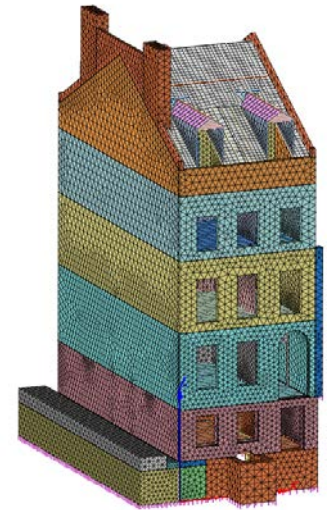
*3D finite element mesh*

Atkinson-Noland & Associates was retained to analyze conditions on site and determine whether the anticipated foundation settlement will produce damage, and if so, the likely locations of damage, and the extent of cracking or other forms of damage. To investigate the likelihood of damage to the House, an advanced 3D finite element analysis was conducted using nonlinear material formulations for the exterior masonry walls and interior wood framed partition walls.

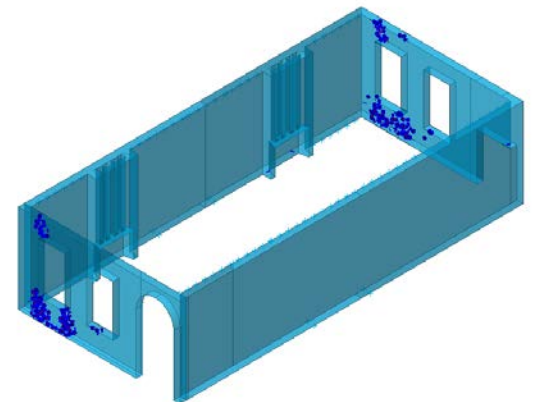
*Likely damage at 1<sup>st</sup> floor masonry walls based on FE analysis*
