PROJECT

Trinity Church
New York, New York

PROJECT DESCRIPTION

SERVICES PROVIDED BY ATKINSON-NOLAND

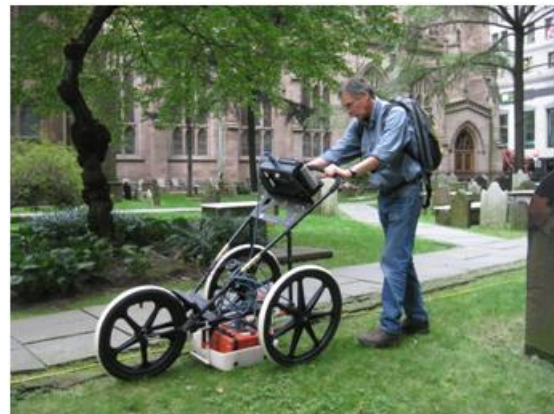
Right Above: Trinity Church
Right Below: Radar survey of church cemetery.

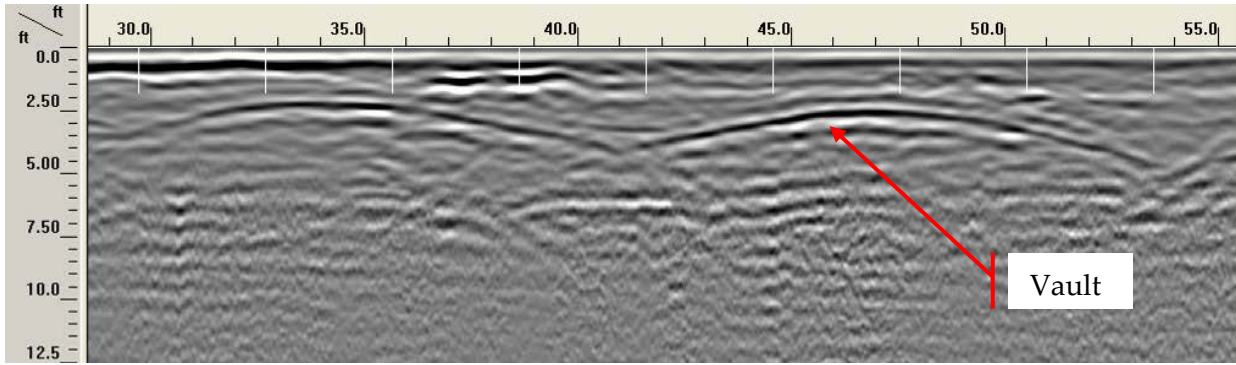
Typical radar profile recorded at graveyard. Two large curved features are visible, indicating the presence of vaults with crown located 2'-6" below grade.

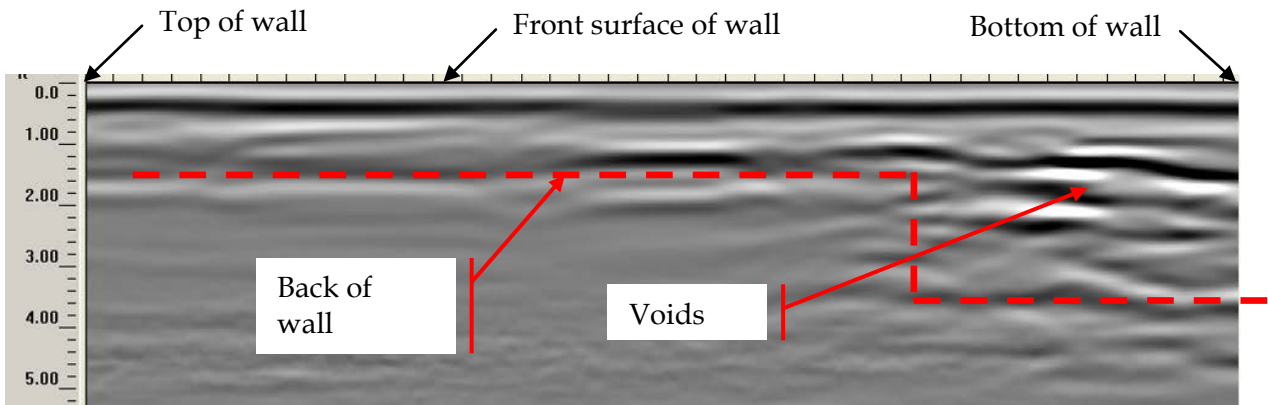
Typical radar profile of retaining wall with different thickness along the height. Voids are visible at the base of the wall. Scale at left in feet.
