Theodore Roosevelt Executive Building Long Island, New York

Robert Silman Associates New York, New York

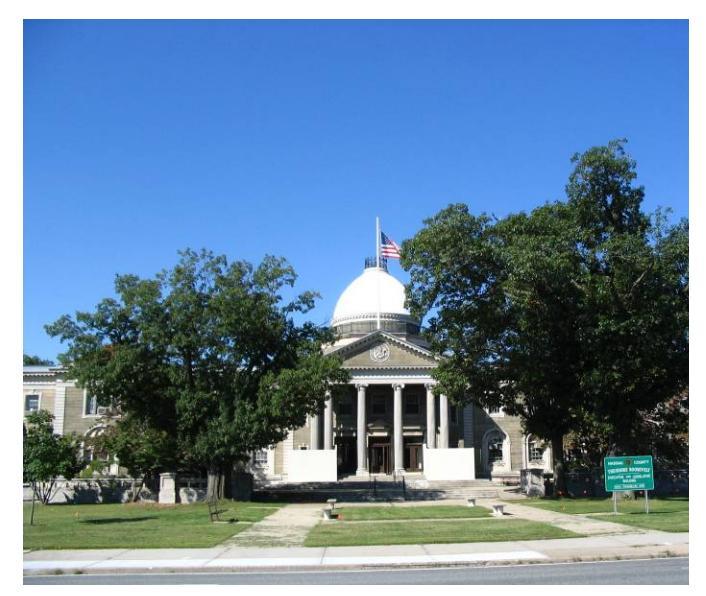
Right: The Theodore Roosevelt Executive Building, originally called the Nassau County Courthouse, was constructed beginning in 1900 and used a patented system of twisted square steel reinforcement and voided concrete floors and walls.
