Calvary Episcopal Church
Pittsburgh, Pennsylvania

PROJECT DESCRIPTION

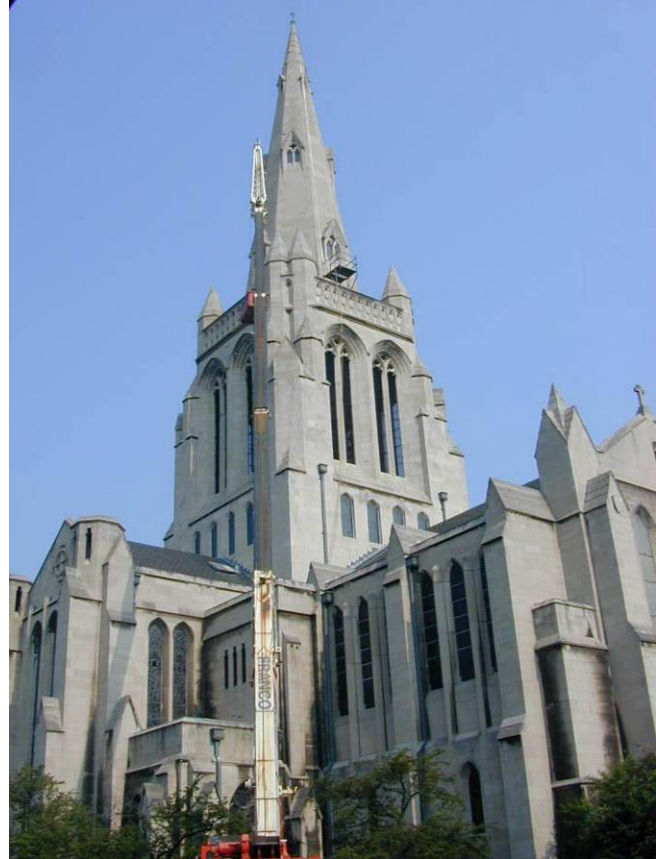
The Calvary Episcopal Church was constructed between 1906 and 1907 and was built using traditional masonry construction. The architecture of the church is Gothic Revival with a central tower over the crossing. The church exterior is clad with Indiana limestone over a clay masonry backup. The spire, however, is clay masonry at the base and transitions to solid limestone approximately 8 feet above the base of the spire. Cracks and spalls are visible in the limestone of the bell tower and spire.
