Montgomery Monument, St. Paul's Chapel
New York, New York

The Montgomery Monument, commissioned by Congress in 1776, was sculpted in France and later installed at St. Paul's Chapel in New York City in 1779. The sculpture was installed on the east elevation of St. Paul's where it is partially protected from the elements by the portico. The monument has numerous visible cracks and differential movement, primarily due to rust jacking of ferrous supports installed some 230 years ago. ICR requested investigations by Atkinson-Noland to locate metal inclusions in the monument and assess the effects of subway vibrations on the monument.

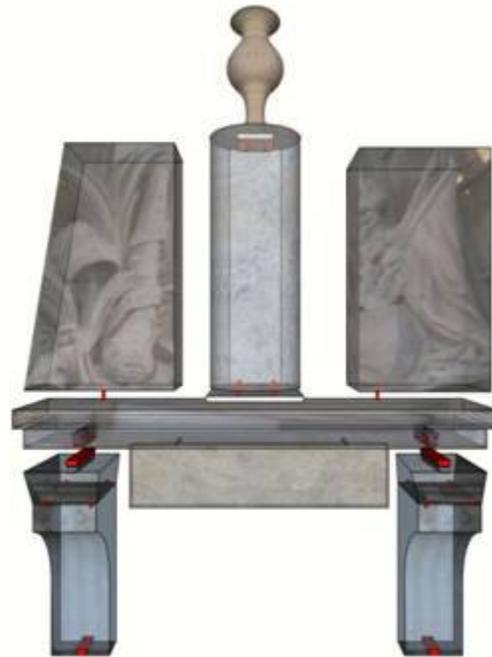
Location of metal pins identified.

- Location of metal pins and cramps in stone elements to facilitate deconstruction and stabilization
- Vibration monitoring to evaluate maximum particle velocities and assess the potential for subway car vibrations damaging the monument
