PS 14X

Bronx, New York

NYC School Construction Authority

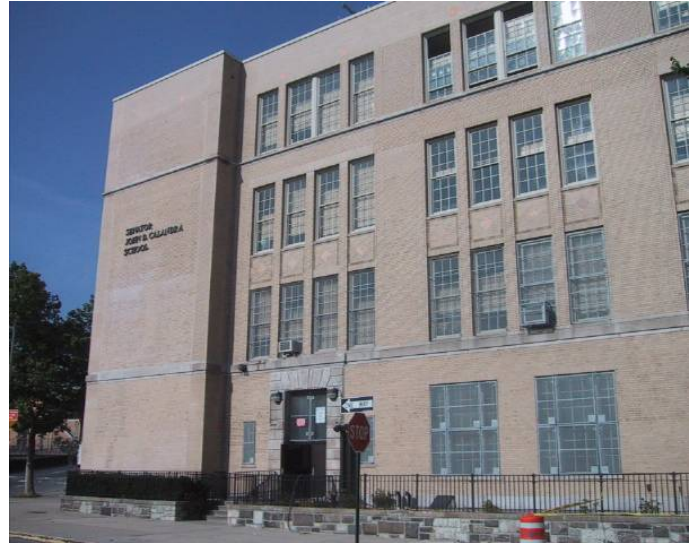
PS 14X was constructed in 1934 and has been plagued with moisture penetration problems for years, with associated steel corrosion, deterioration, and mold growth. The structural steel frame, encapsulated within the exterior masonry walls, was beginning to show signs of corrosion, and previous attempts to repair the building and eliminate moisture penetration were not successful. A repair scheme was developed to inject a mortar-like cementitious material into cracks and interior void spaces to fill moisture pathways and stabilize the remaining masonry. Large-scale water penetration tests showed the repair successfully eliminated over 98% of moisture penetration. The work was done with the building remaining fully operational and without altering the appearance of the historic façade. A cathodic protection system, designed and installed by our technical partners Masonry Solutions International and Electro-Tech Ltd., eliminates future steel corrosion and ensures a 75-year life for the existing repairs.

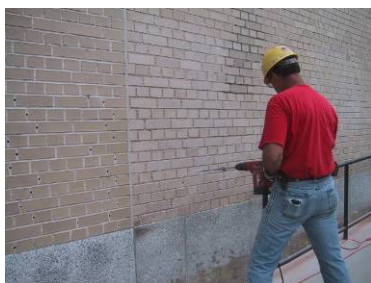
Masonry Solutions International technician preparing the wall for injection. A cementitious injection material was specially formulated to be compatible with the historic brickwork. Water penetration was eliminated by injection of the material through small-diameter holes drilled into mortar joints to fill interior voids and cracks. Following injection, an impressed current cathodic protection system was installed to protect structural steel against future corrosion.
