Washington, Pease, and Fannin
Elementary Schools
Masonry Wall Grout Injection

Midland Independent School District
Midland, Texas

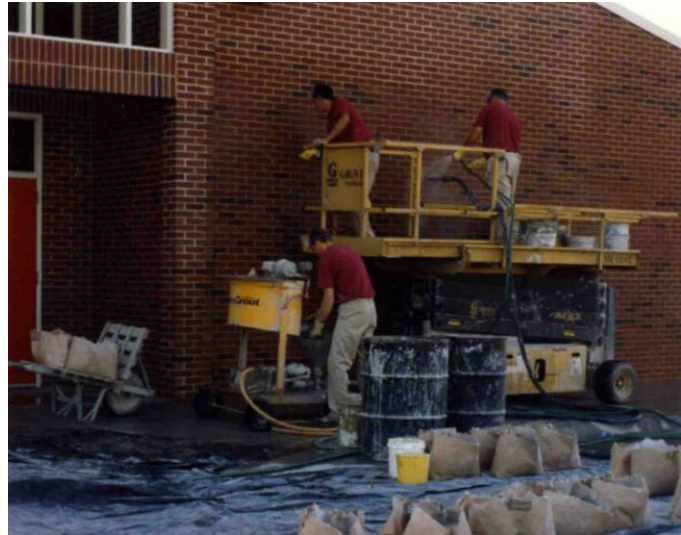
Right: Collar joint grout injection
underway at Pease Elementary School.

Atkinson-Noland & Associates teamed with Masonry Solutions International for this project. All cavities were filled with a cement-based grout using a small crew and mobile injection equipment. Grout injection did not interrupt normal building operations and the school buildings continued to operate during the entire process. Following injection, grout penetration was verified by nondestructive impact-echo testing and borescopic examinations.
